**Oak Tree Report**  
**for the**  
**Estrella River Vineyard**  
**Tract 2905**

Estrella Road  
Paso Robles  
San Luis Obispo County

**April 2008**

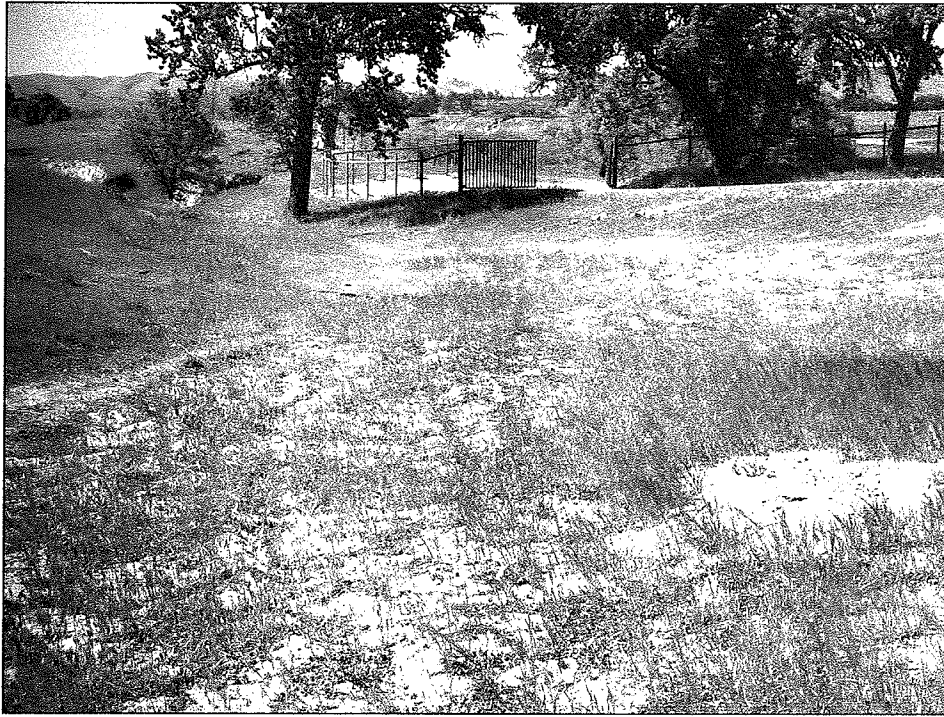
Photo 1. View north of the front gate entrance to the property from Estrella Road. The existing vineyard road would be re-aligned. Tree #1, pictured left of the gate, would be impacted.

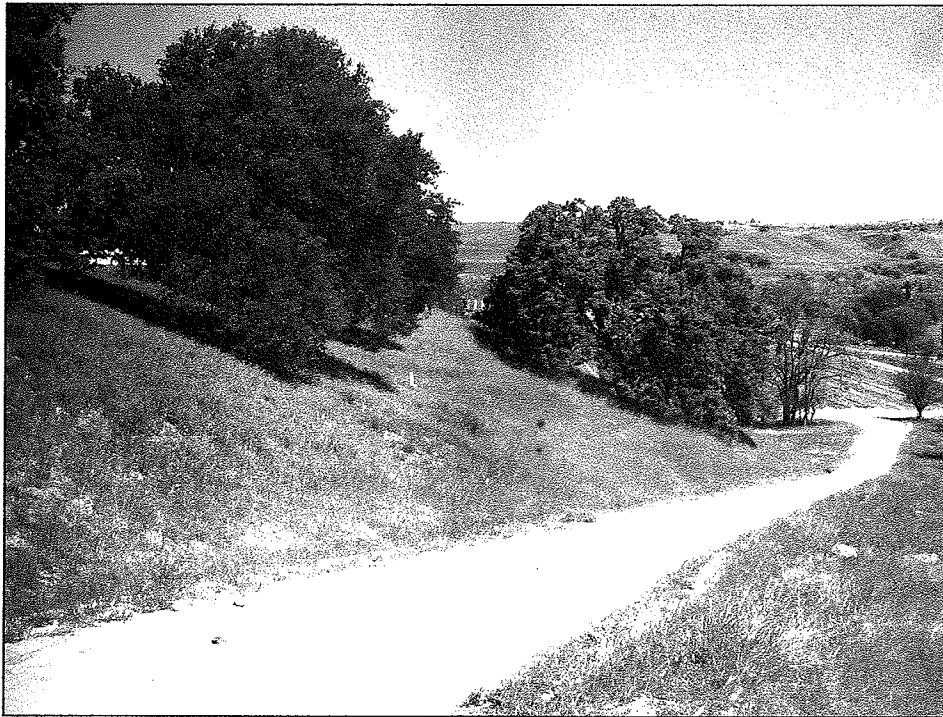
Photo 2. View north of the existing agricultural road along the east property border that would be paved and widened. The deciduous trees at the base of the road are non-native tree of heaven. Native blue oaks are visible at left.

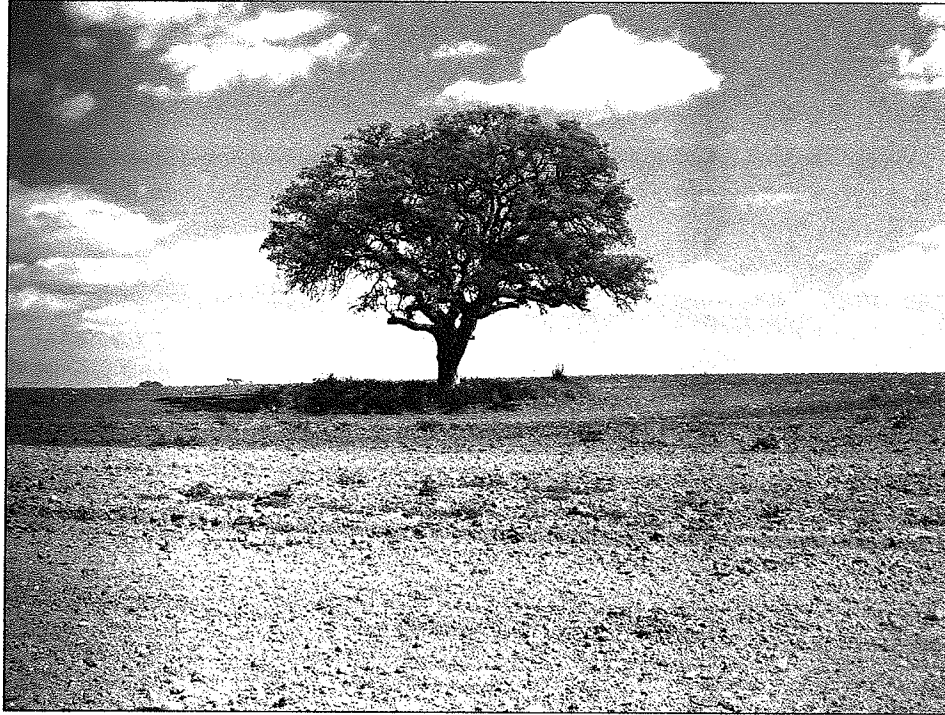
Photo 3. Tree #15 is a 33 inch blue oak (rated "C") located in an existing agricultural field, where the ground is plowed seasonally within the CRZ. The proposed access road would require paving within the CRZ.

- a. It appears from the site plan that paving would occur within the CRZ of several oak trees. Any paving within the CRZ shall be done with porous pavers that will allow oxygen and moisture exchange to occur within the root zone.

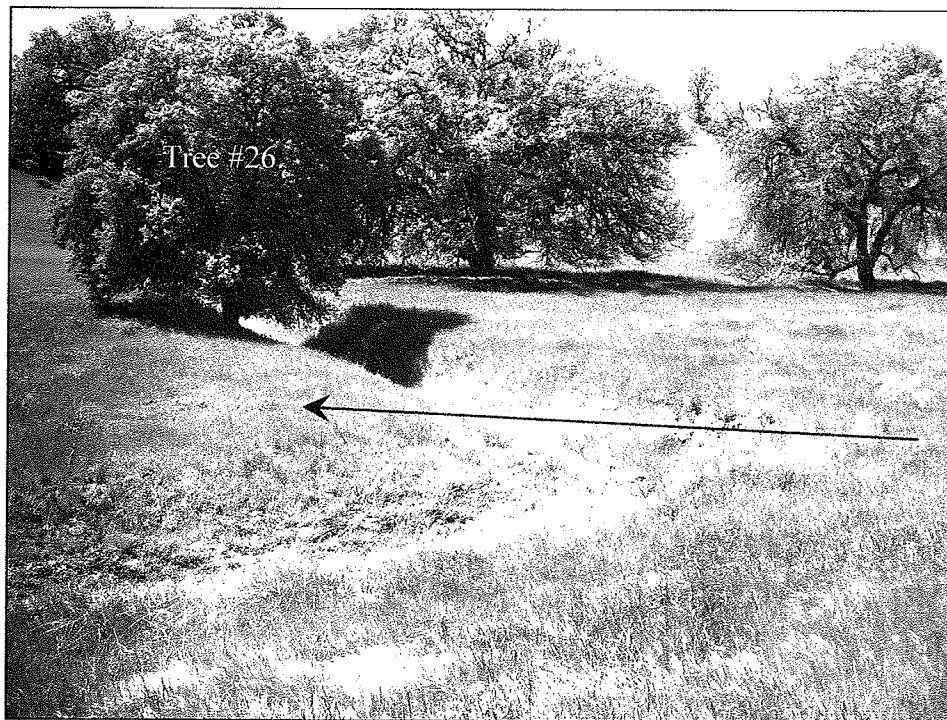
Photo 4. Tree #26 is a very healthy blue oak (rated "A") located along an ephemeral drainage. The southern drainage crossing is proposed at this bend in the stream (note arrow), and would encroach within the CRZ of this tree.

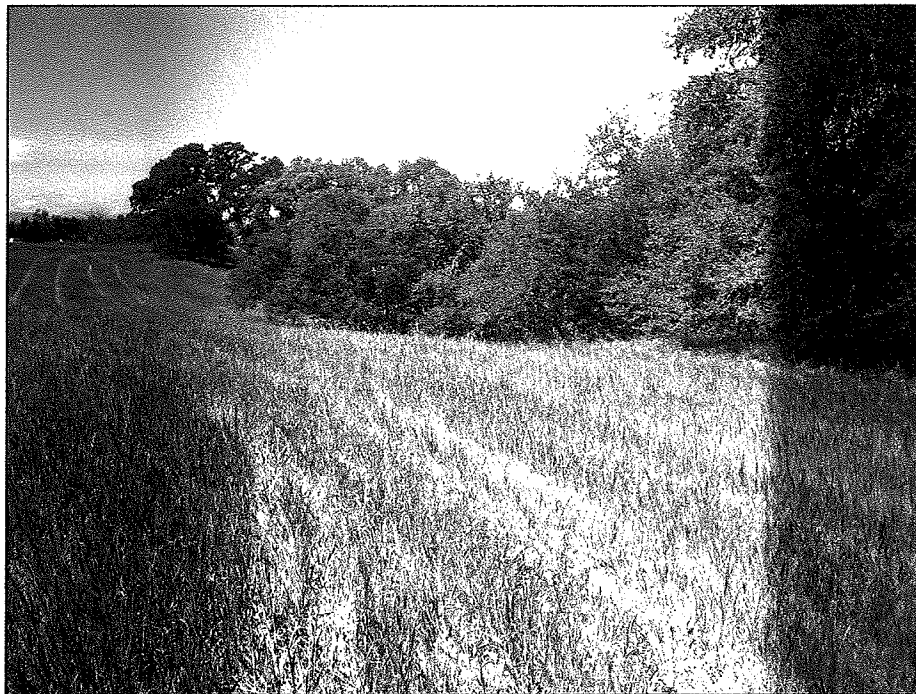
**Photo 5.** View north of the tree line along at the top of the oak woodland at Lots 3 and 4. Building envelopes have not been established, but there appears ample room to avoid impacts to these trees during home construction.

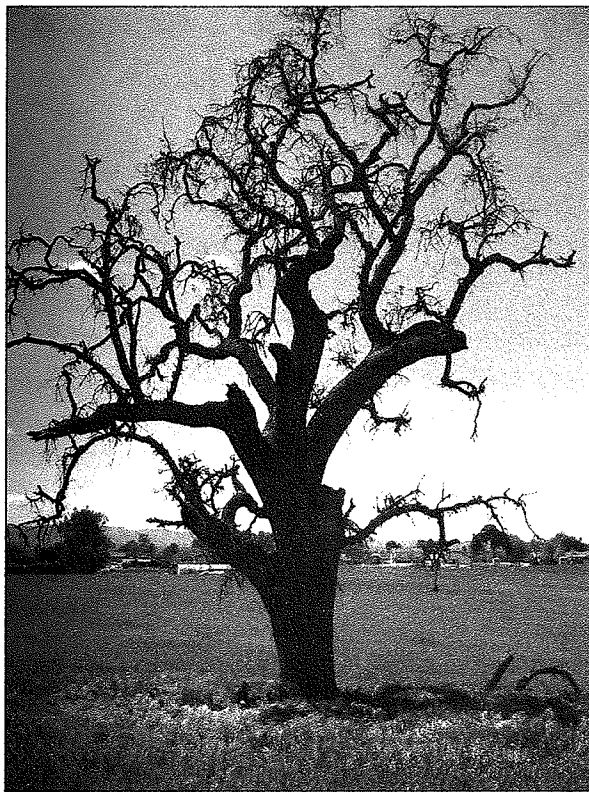
**Photo 6.** Tree #97 is a valley oak in poor health. It has numerous natural cavities, including one harboring a barn owl nest. Although it is nearly dead, it was rated "D+" because of its habitat value to wildlife.

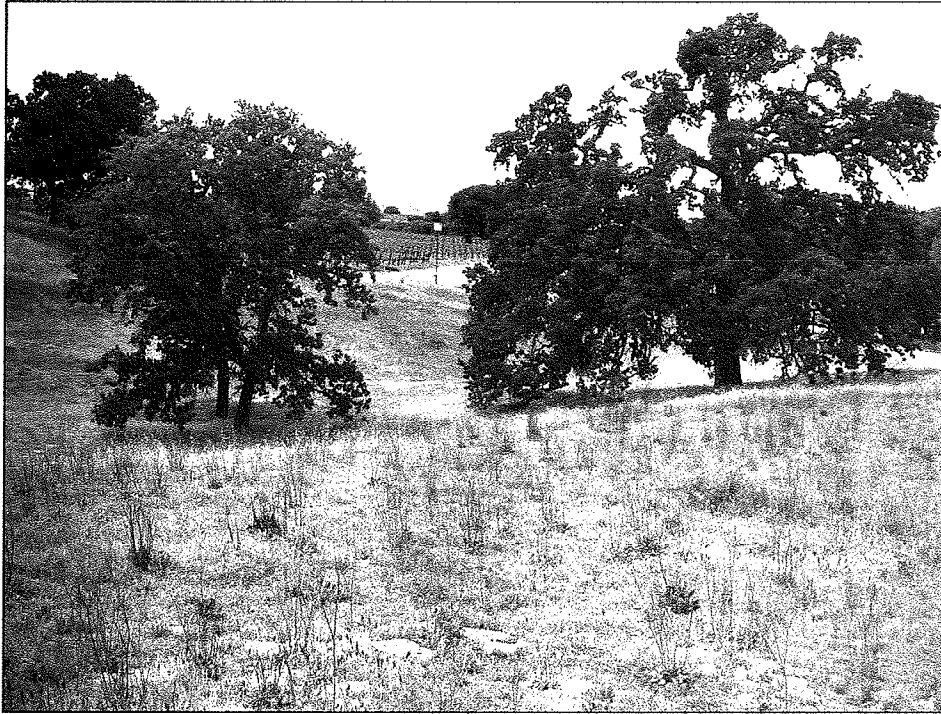
Photo 7. View northwest of Tree 8 (right) and Trees 101 and 102 (left) near the front entrance gate at Estrella Road. The proposed entrance road would pass between these trees, resulting in CRZ encroachment impacts.
